May 1, 2019

Property: Tilton-Northfield Fire District
Park Street Fire Station
149 Park Street
Northfield, NH 03276

Re.: Engineering Consultation for Feasibility of Structural Renovations at the
above referenced property

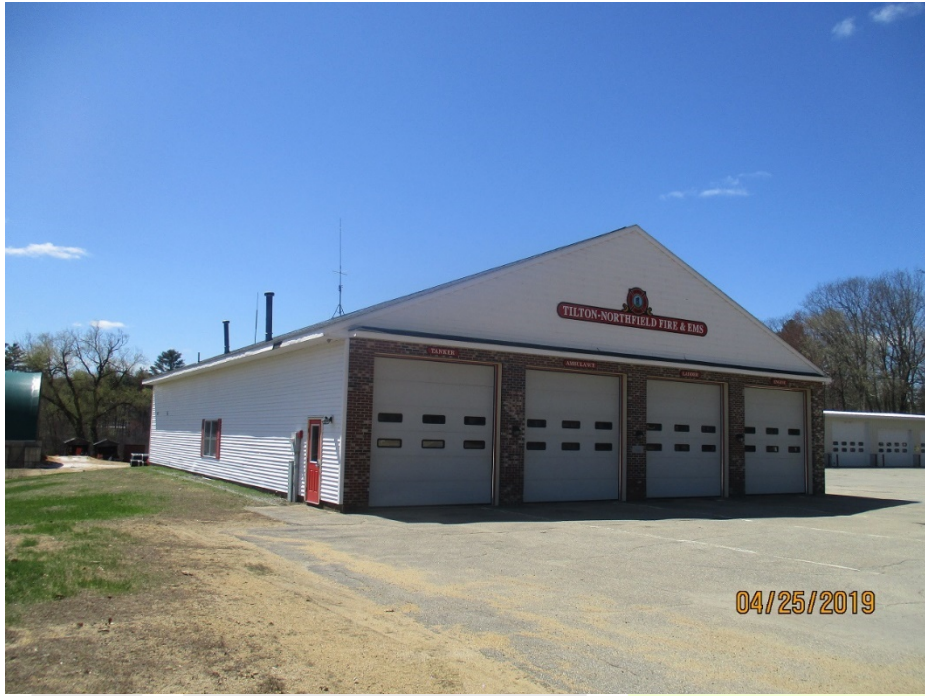
Photo: 1

Description:
Front and left
elevations from Park
Street

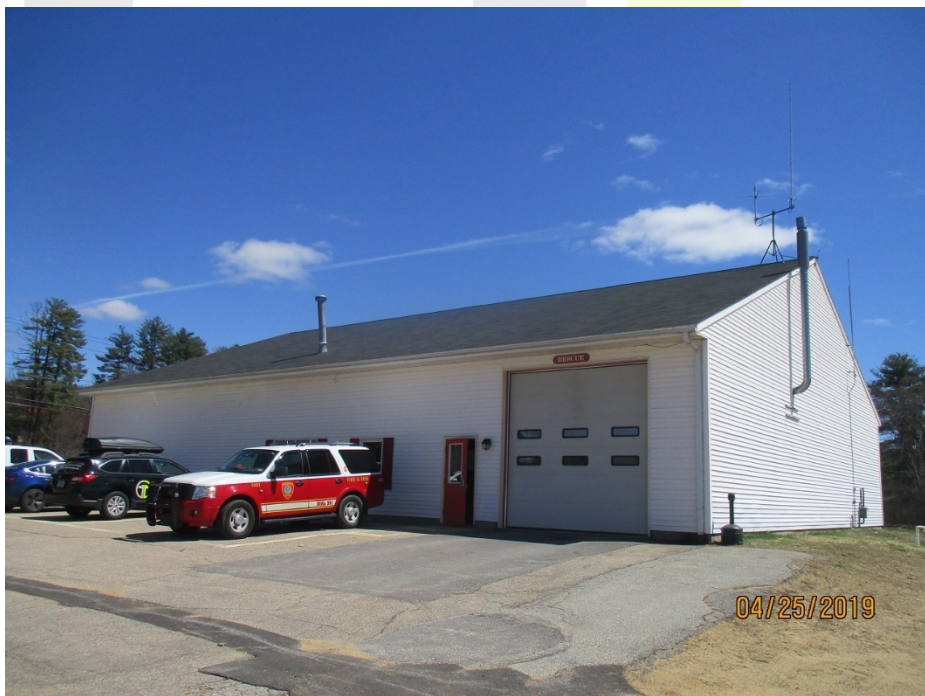
Photo: 2

Description:
Right and rear
elevations

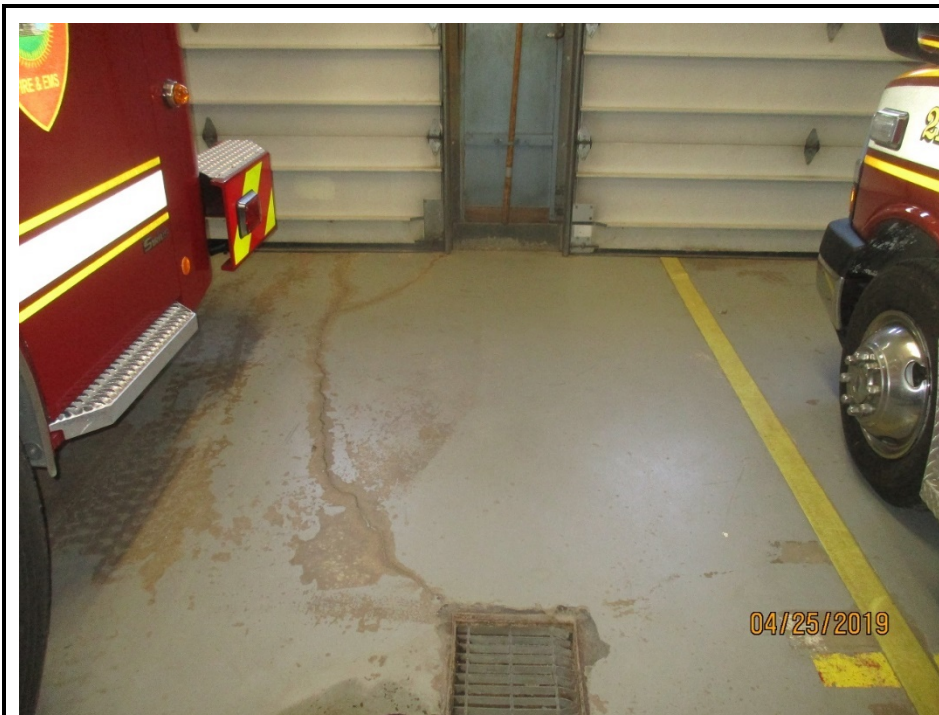
Photo: 3

1. The concrete floor slab contains significant cracks that are likely an indication that the slab has been overloaded by the heavy emergency equipment. Chief Sitar believes the slab is about 5 inches thick.
2. There is staining on the interior ceiling and walls clearly matching the truss and wall stud spacing. The staining could be a result of the timber structure experiencing excessive moisture, which over time compromises its structural integrity. The staining may also be a simple function of the typical lower insulating values of framing relative to adjacent

Description:
Concrete slab cracks
at the front middle

The concrete floor slab is obviously underperforming for the loads it has experienced from the emergency equipment. The slab should be removed and replaced with an adequately designed slab, which will likely be 8 inches thick or more with a mat of steel reinforcing bars.

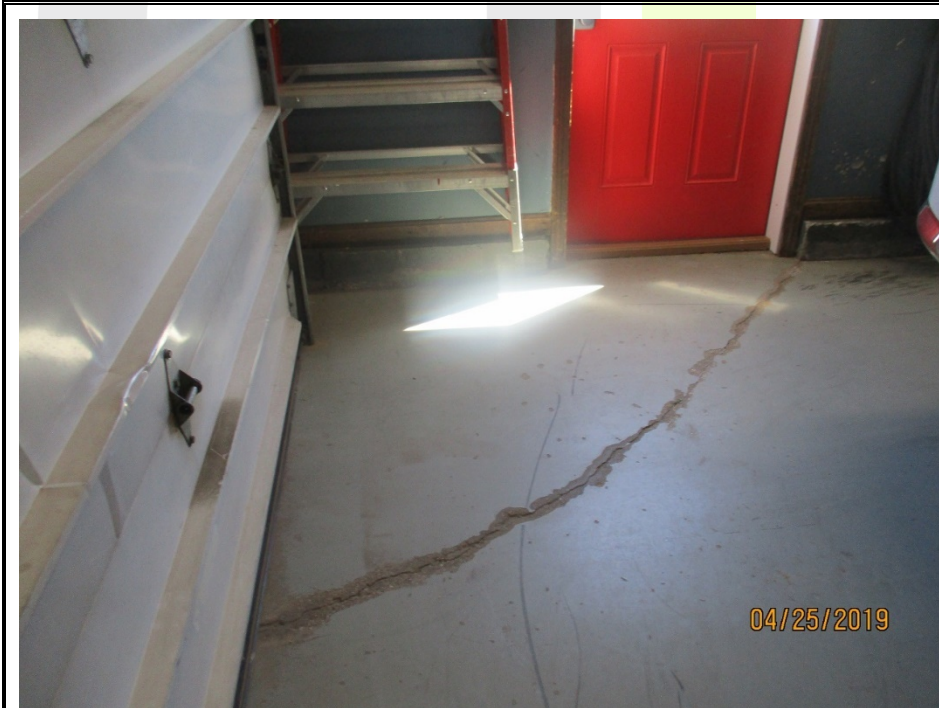
Photo: 4

Description:
Typical concrete slab
cracking at the front
corners

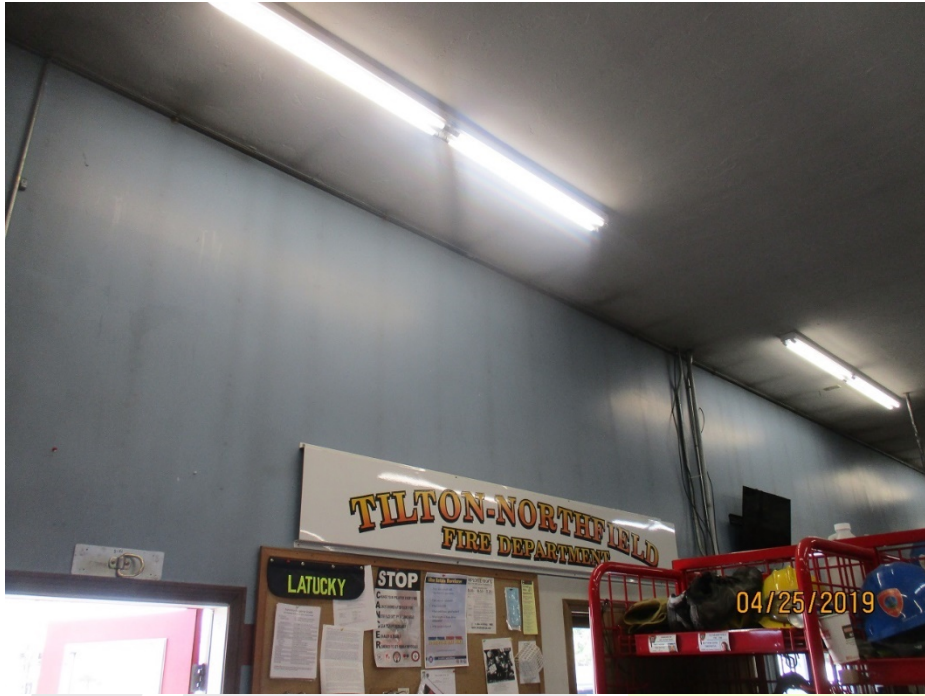
Photo: 5

insulated wall cavities. We did not observe any other signs of excess moisture in the attic, despite limited ventilation (only soffit and ridge vents).

Description:
Staining on the walls and ceiling at every stud and truss could be indicative of excessive moisture or differences in insulation between framing and insulation

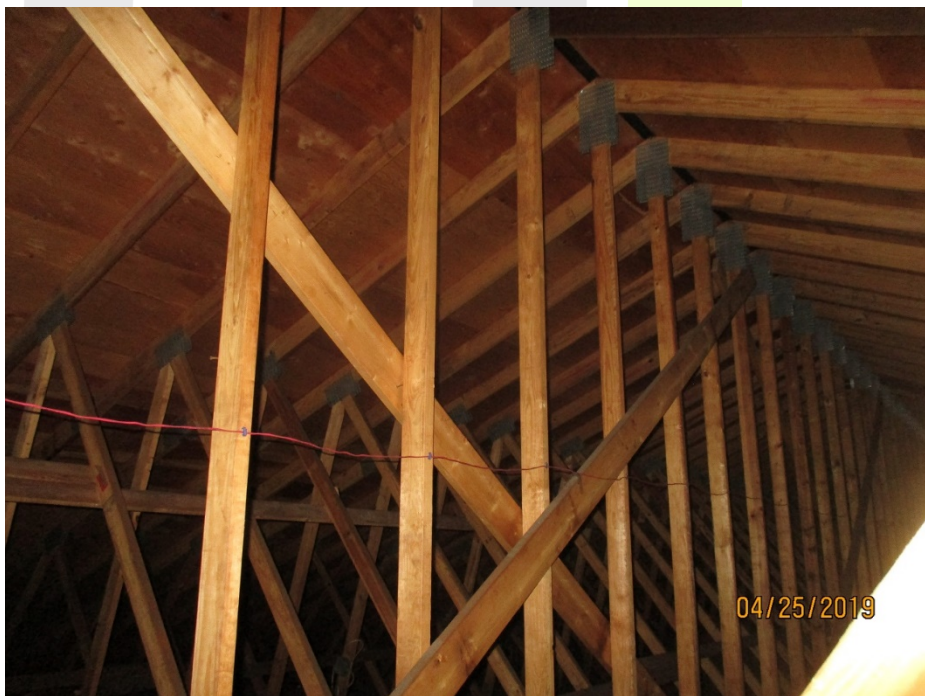
Photo: 6

The design ground snow load in 1986 was 40psf, whereas today it is 75psf in Northfield.² While we did not perform structural analyses to determine the gravity load-carrying capacity, our experience is that “pre-engineered” systems like wood trusses are efficiently designed very close to the design loading. Options to upgrade include sistering similar trusses to every existing truss or replacing the roof structure completely with adequately designed wood trusses.

Description:
View of the middle portion of the roof trusses from the attic
